The
San Francisco Earthquake and Fire

A BRIEF HISTORY OF THE DISASTER

A Presentation of Facts and Resulting Phenomena, with Special
Reference to the Efficiency of Building Materials
Lessons of the Disaster

A. L. A. HIMMELWRIGHT, C.E.

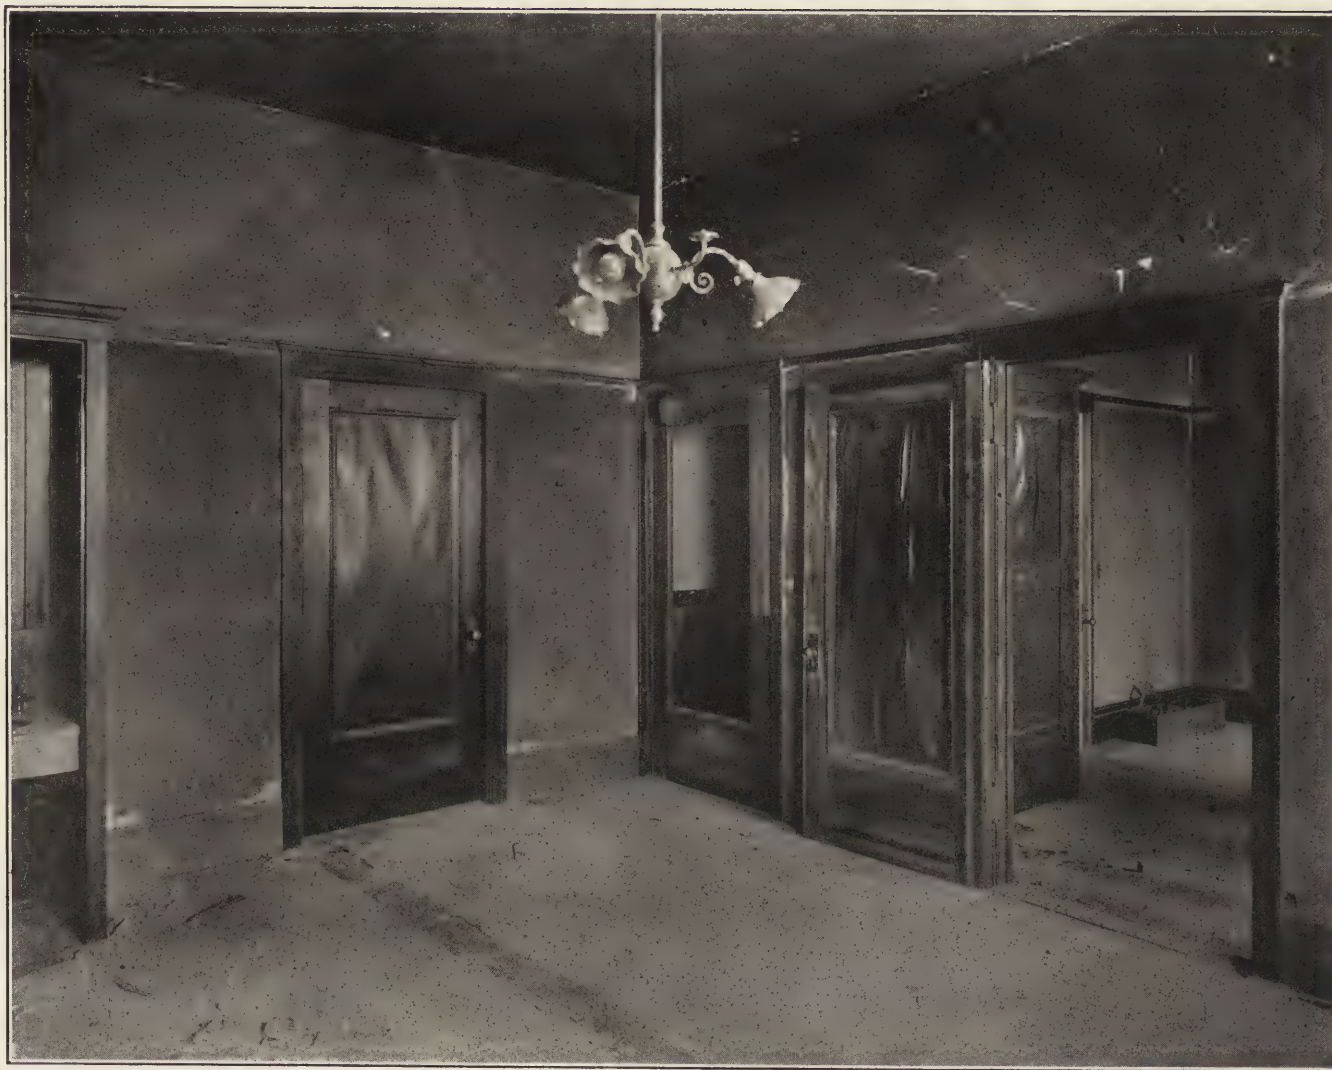
ATLAS BUILDING. Typical view of the lower stories. Metal lath and plaster partitions and ceilings, cement finished floors. The cracks in the plaster were caused by the earthquake and the dark color by smoke.

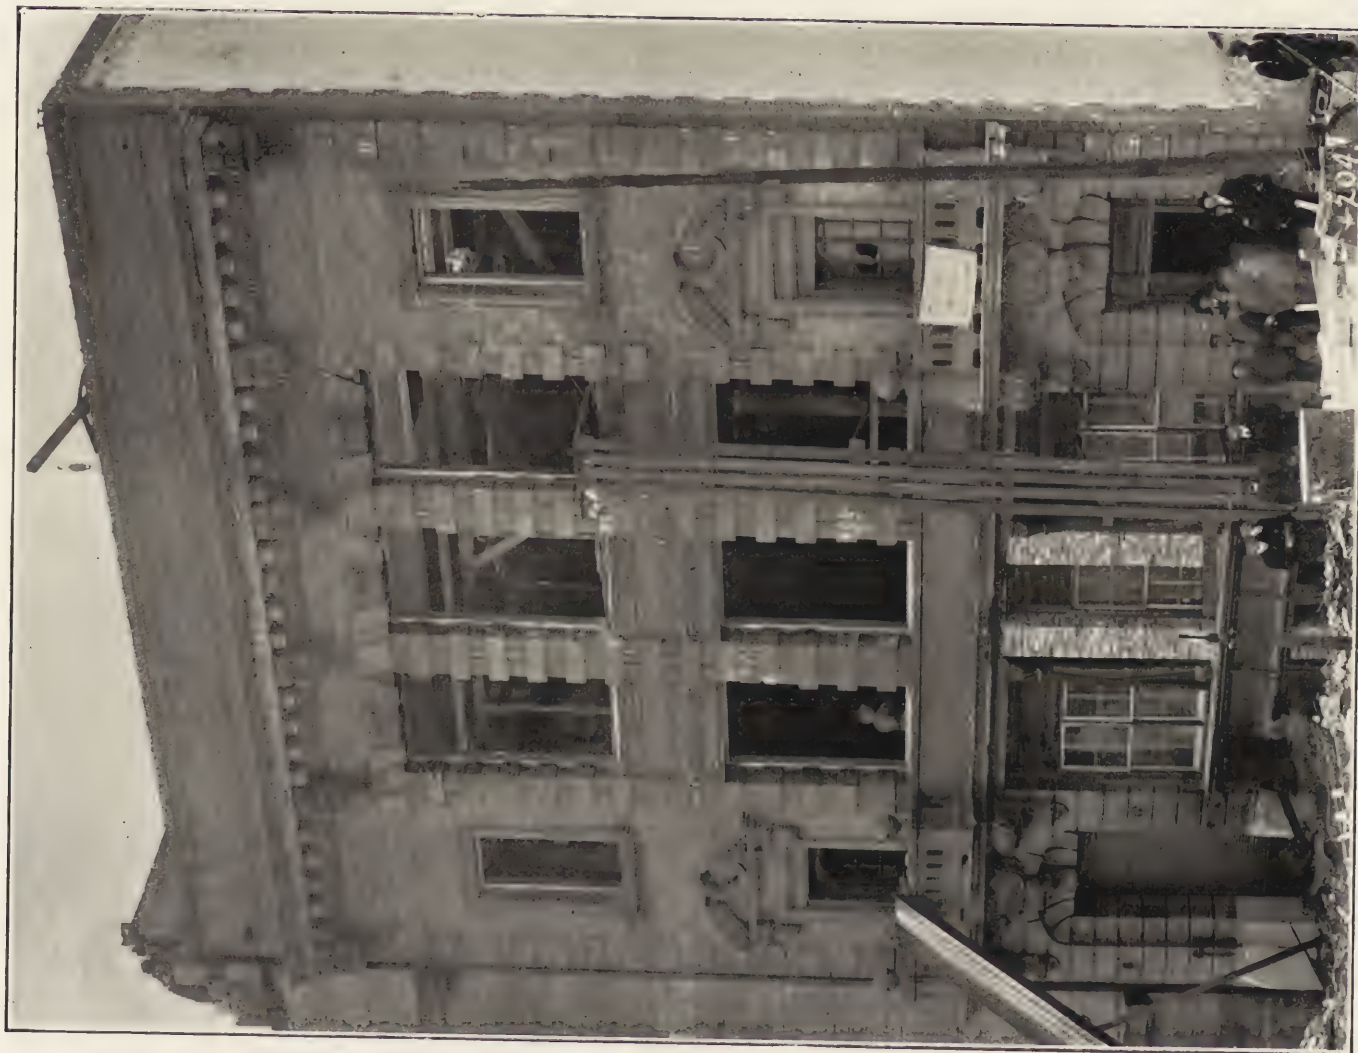
PACIFIC STATES TEL. & TEL. CO.'S East Office, 821 Hyde St. The facade consists of a granite base, with buff terra-cotta brick and terra-cotta ornamentation above. The granite base is slightly damaged, but the rest of the front is in good condition. Two cast-iron pillars, at the first-story level, were deflected by the fire, and have been reinforced by new brick piers. This building was subjected to a normal fire only. It is structurally uninjured. The expanded metal concrete floors are only in fair condition, the cinder concrete having been of poor quality originally. The concrete column protection and the floor finish of cement remain in good condition.

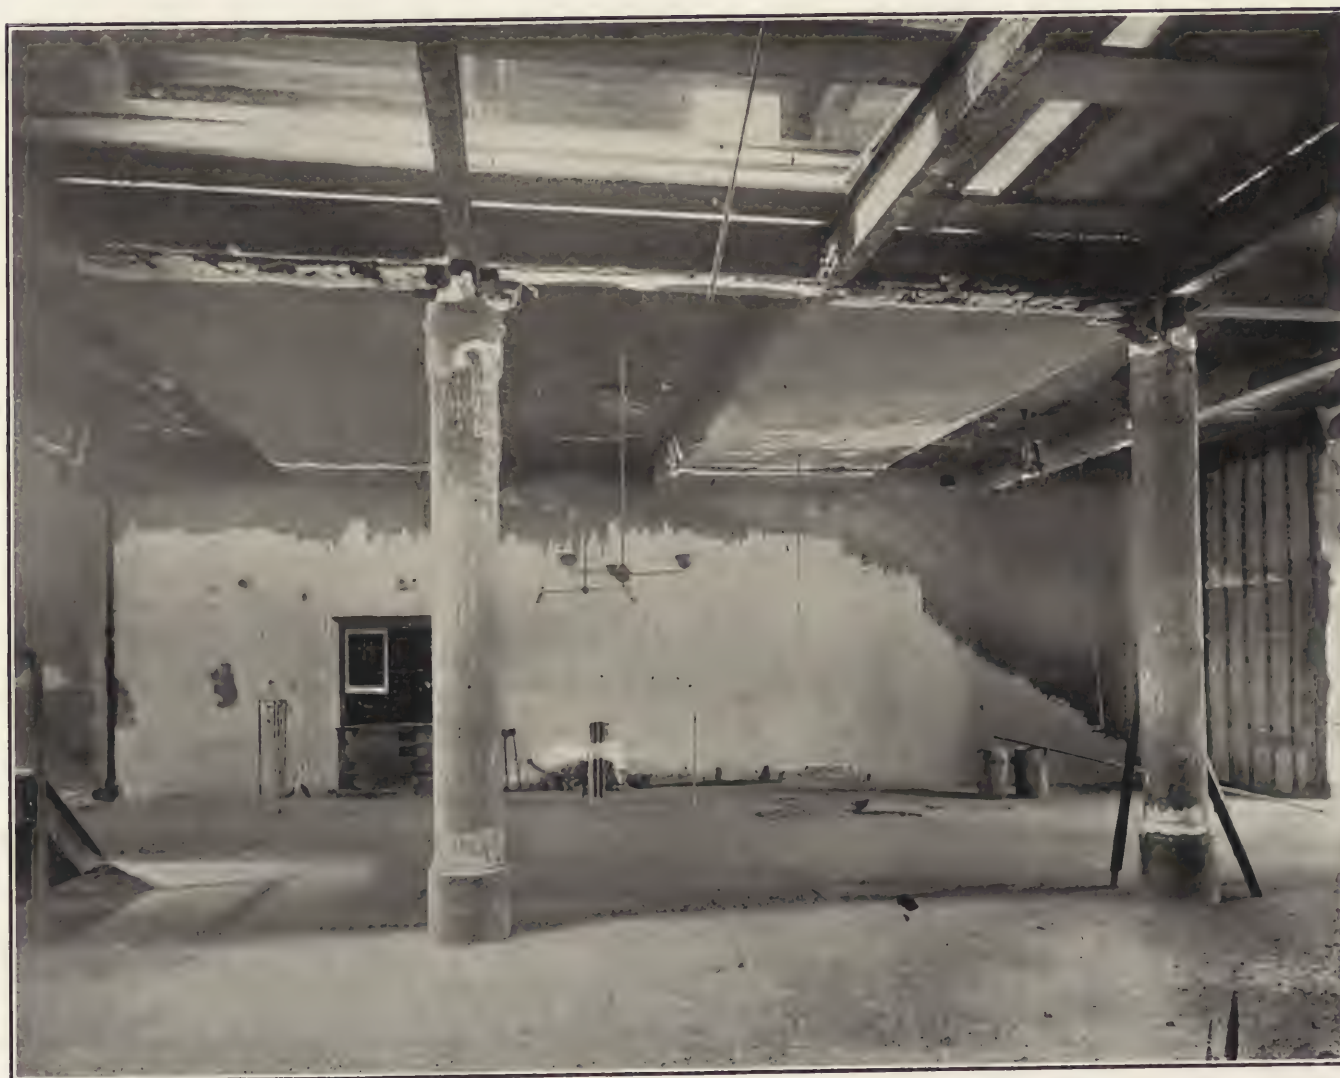
PACIFIC STATES TEL. & TEL. CO.'S East Office. Showing the typical condition of the concrete column protection and the damage to the cast plaster ornamental caps. The concrete protection should not have been omitted where the caps were placed. The photograph was taken after repairs had been begun.

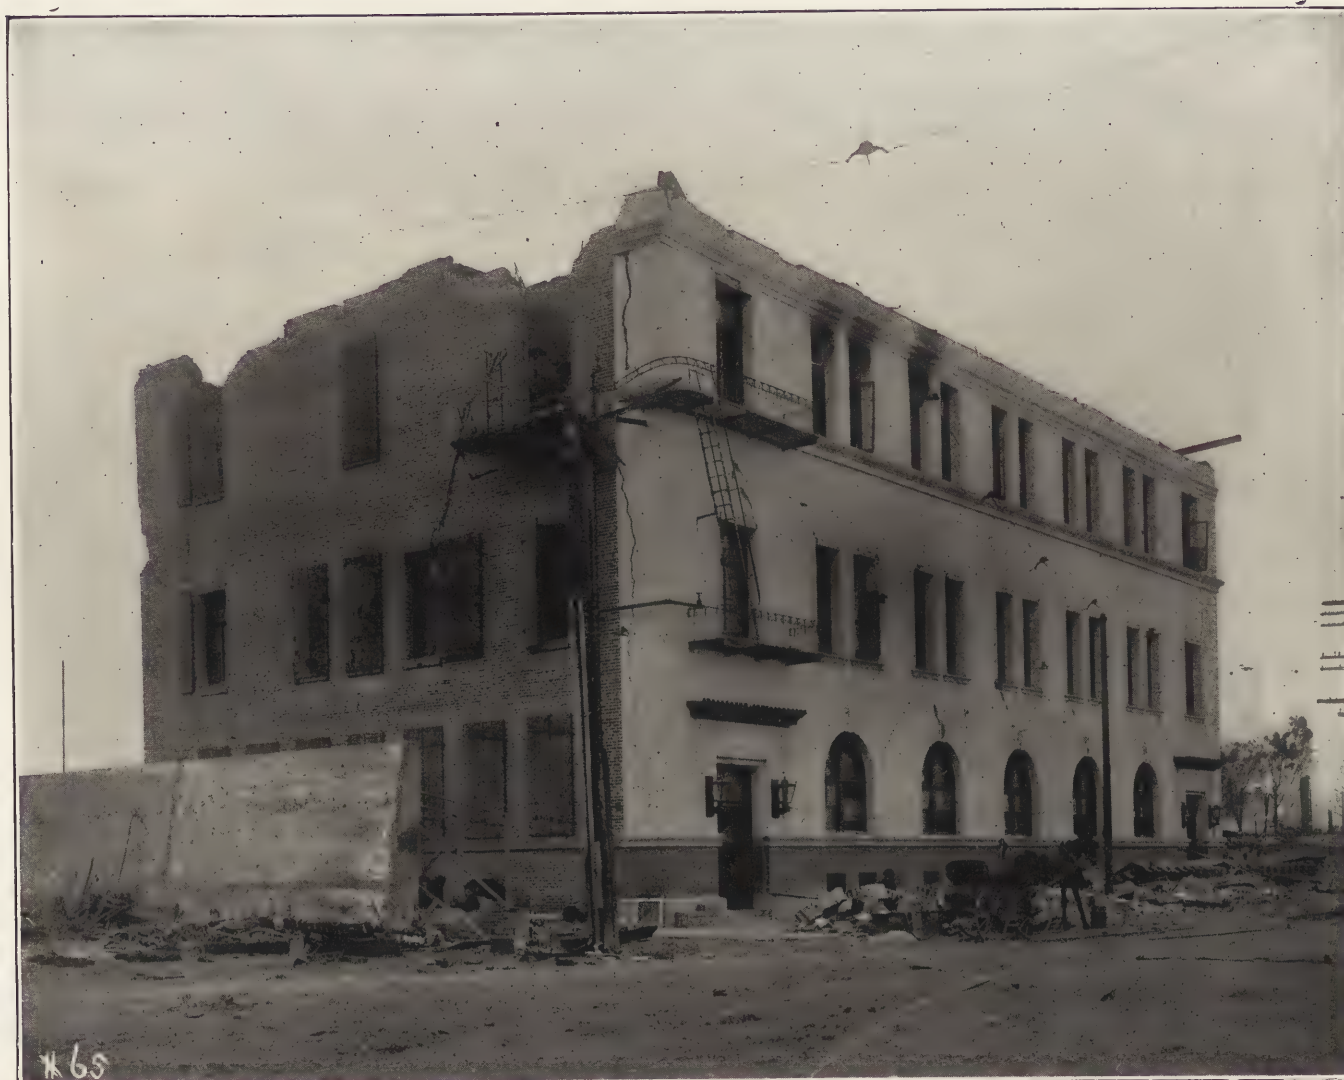
This building was but slightly damaged by the fire, most of the injury sustained by it being caused by the earthquake. The artificial stone base and buff terra cotta brick are practically uninjured. The white cement plaster finish of the upper stories is badly disfigured by earthquake cracks. The south wall at the southwest corner has cracked loose from the west wall, from the top to the bottom. The east and west walls are shaken and racked so that sections of the southeast and northwest corners fell out. Portions of the roof arches being unsupported after the walls fell out, dropped down into a vertical position and are supported by the steel beams adjacent to the walls. The north

PACIFIC STATES TEL. & TEL. CO.'S South Office, 74 and 76 West Mission Street. The façades consist of gray artificial stone to the water table, buff terra cotta brick to half the height of the first story and white cement finish on common brick above. This building had a temporary wood roof supported by the fourth floor, it being intended to increase the height of the building later. The top of the side walls and the parapet walls were overthrown, and portions of the walls were cracked and badly damaged by the earthquake. The two lower stories were provided with metal-covered window frames and sash, with wire glazing, which successfully preserved the contents of these stories. Fire was communicated to the top story through the window openings, which were finished with ordinary wood frames and sash. There was a large amount of expensive equipment and combustible contents in this story, which produced an intensely hot fire. The steel framing and the Roebling concrete floors and column protection remain in first-class condition.

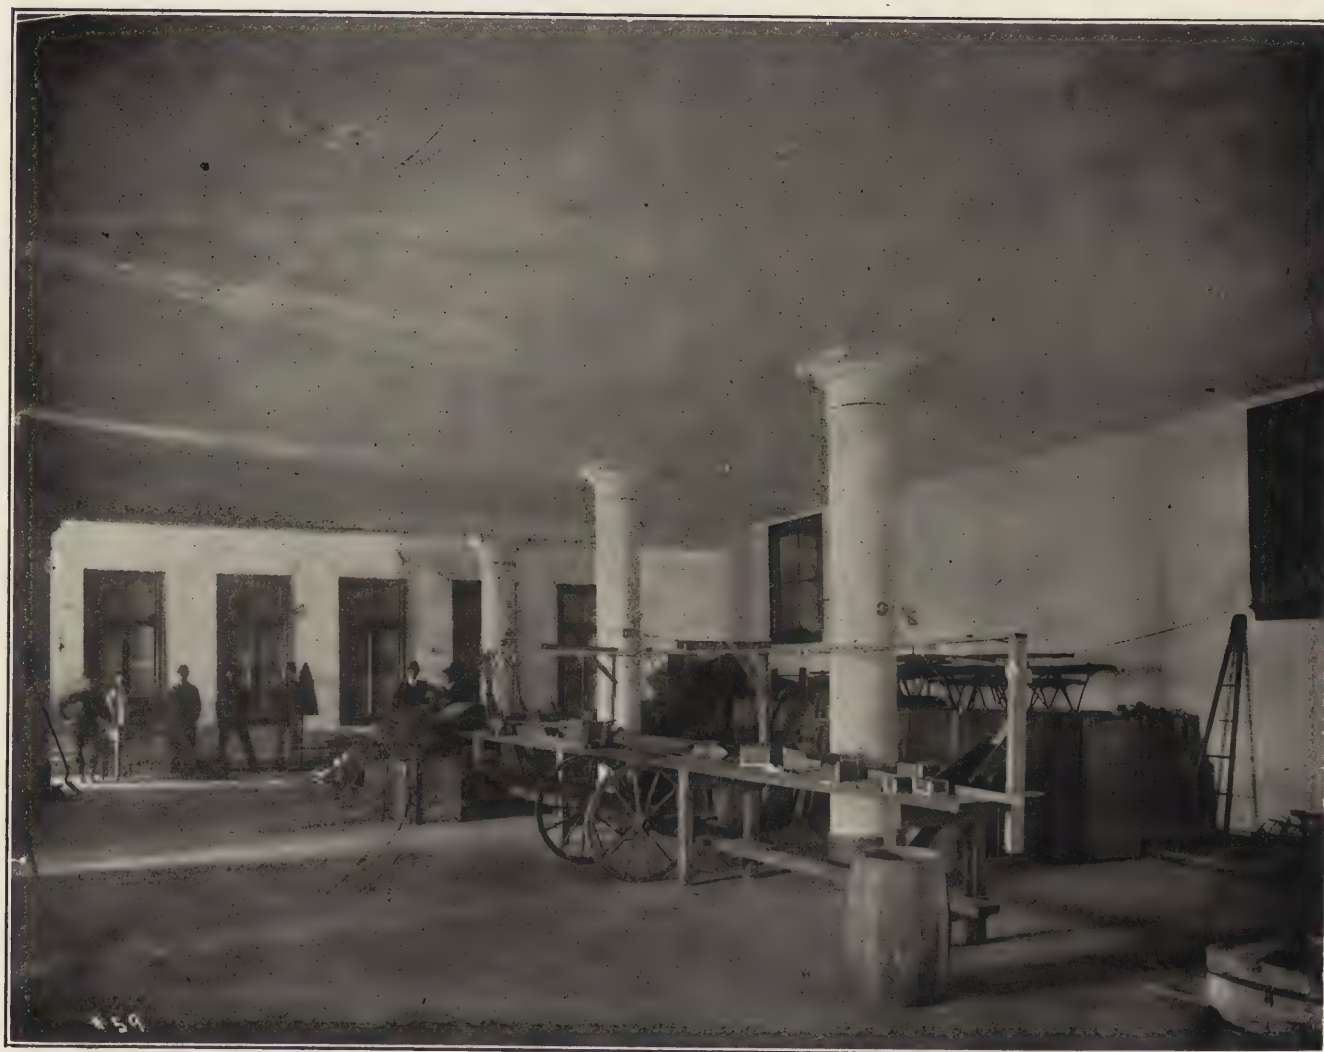
PACIFIC STATES TEL. & TEL. CO.'S South Office. First Story. Showing the condition of the interior, which sustained no fire damage. Note the earthquake cracks and damage to the plaster work in the rear. Everything combustible in the upper story of this building was consumed.

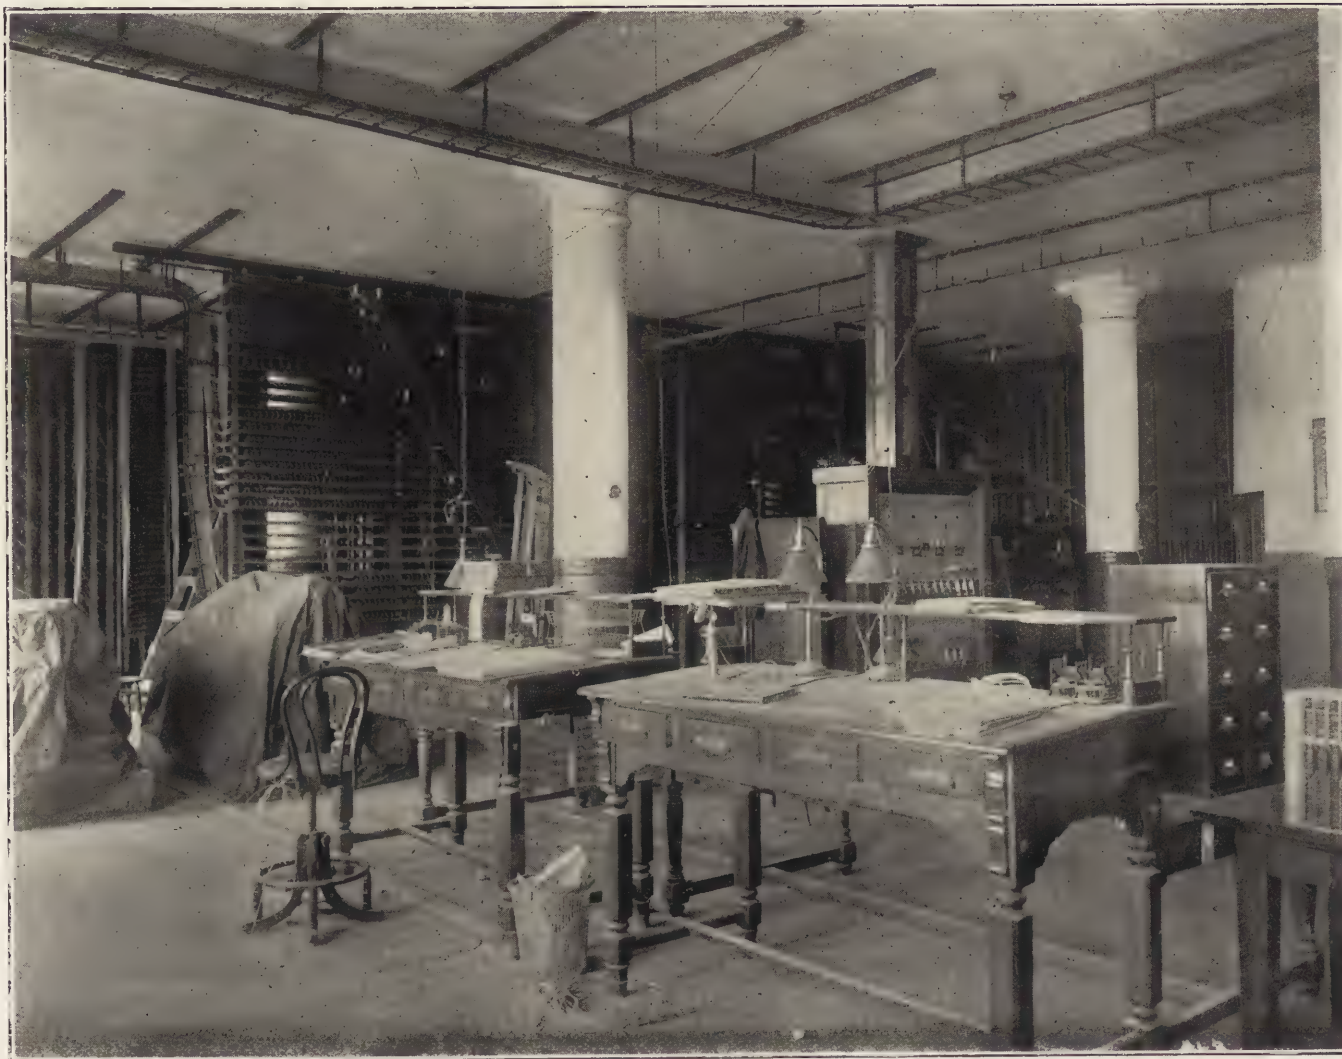
PACIFIC STATES TEL. & TEL. CO.'S South Office. Second Story. The metal covered window frames and sash, with wire glazing, prevented the fire from entering this story. The story immediately above, with unprotected window openings, was subjected to an intensely hot fire without causing the slightest damage to the ceiling or any part of this story. The cable racks, furniture, plastering and cement finished floors were uninjured.

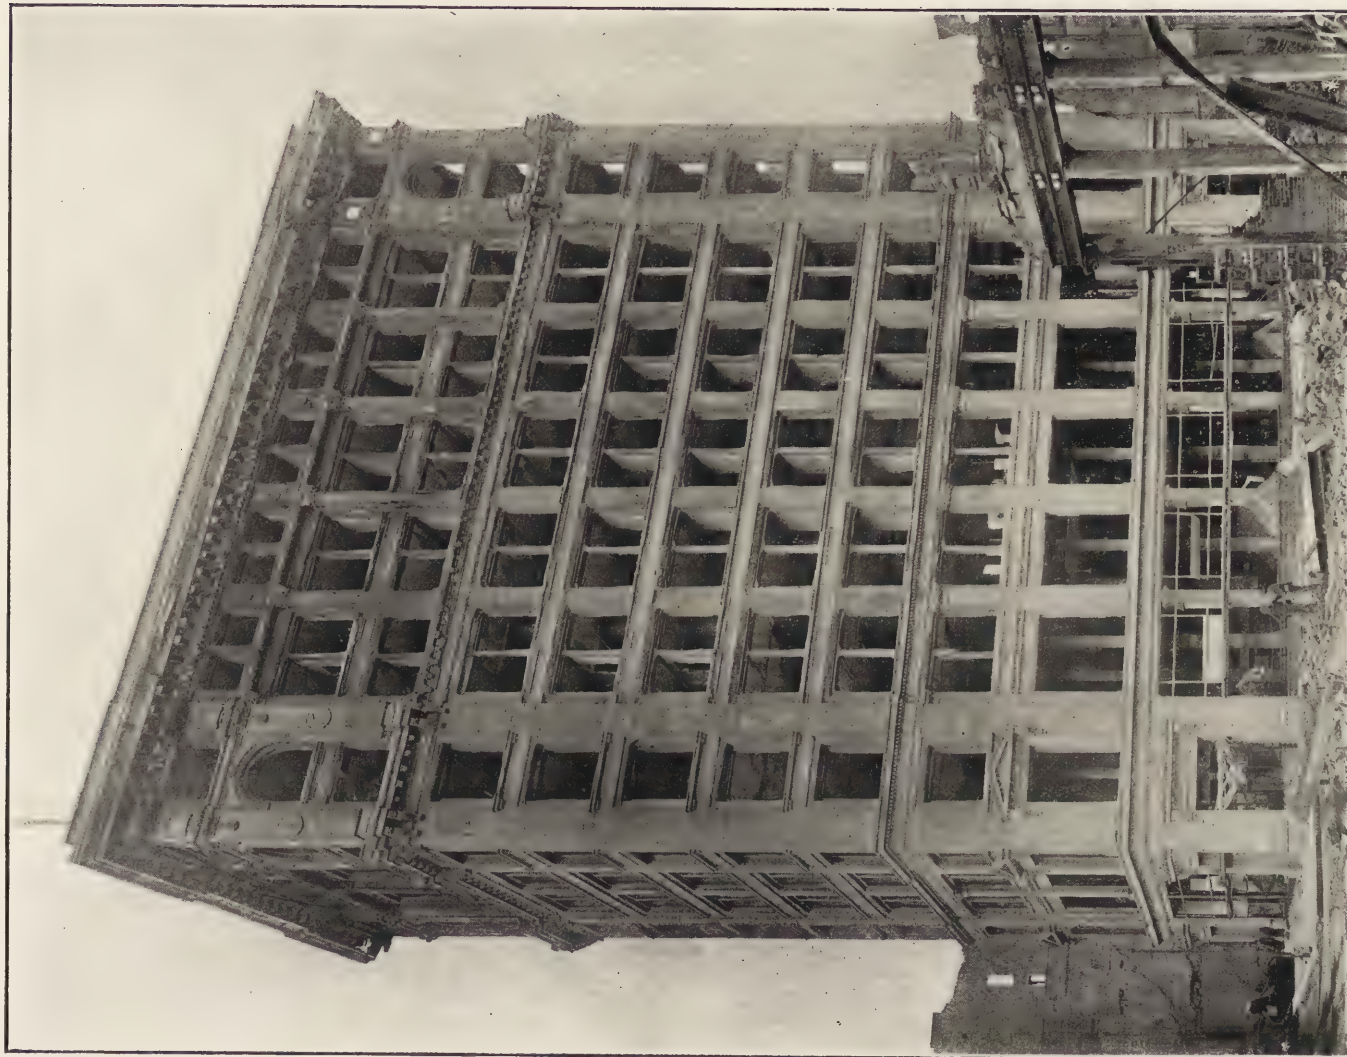
SHREVE BUILDING. Showing the Grant Avenue elevation. The façades consist of gray sand-stone. The entire Grant Avenue side is badly spalled by the fire. The ornamental columns at the ninth and tenth story levels are slivered. The metal cornice is wrecked. The Post Street front is spalled around the window openings, the worst damage being on the west side. There is very little earthquake damage. The Roebling concrete floors and wire lath ceilings throughout are uninjured. The Roebling concrete column protection in the basement, first and second stories, is also in first-class condition, but the 3" hollow tile column protection in the upper stories is considerably damaged, having fallen away in many places. The 4" hollow tile partitions generally are in bad condition, and a large proportion have fallen down.

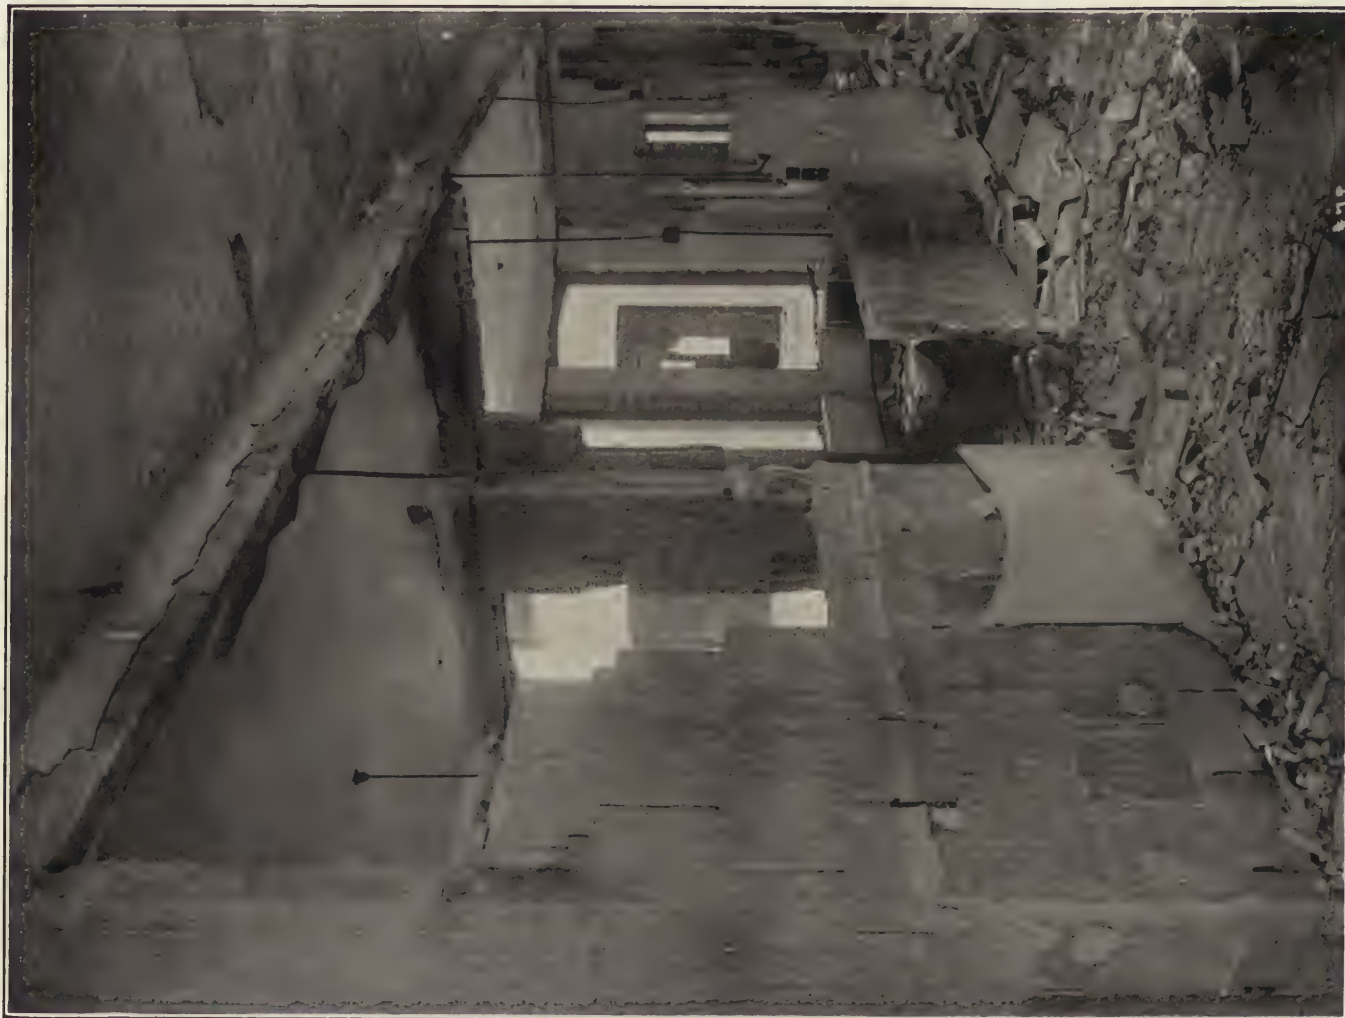
SHREVE BUILDING. Fifth Story. Showing typical condition of the Roebling concrete floors and wire lath ceilings and of the hollow tile partitions and column covering. The protection of the column on the right has fallen away. The hollow tile partitions were carried to the underside of the concrete floors through the wire lath ceilings, and failed in many places from buckling due to expansion.

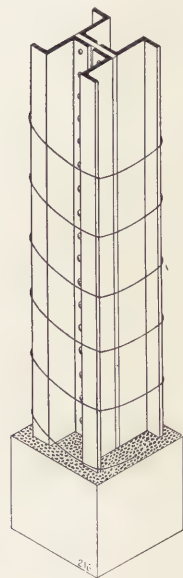
Efficient Concrete Column Protection.

The difference in the efficiency of the two methods of column covering is particularly noticeable in this building. In the three lower stories, where the protection was of concrete, it is entirely uninjured, while in the upper stories, where the protection consisted of 3" hollow tile blocks, and where the fire was less intense, it was badly damaged and has fallen away in numerous places.

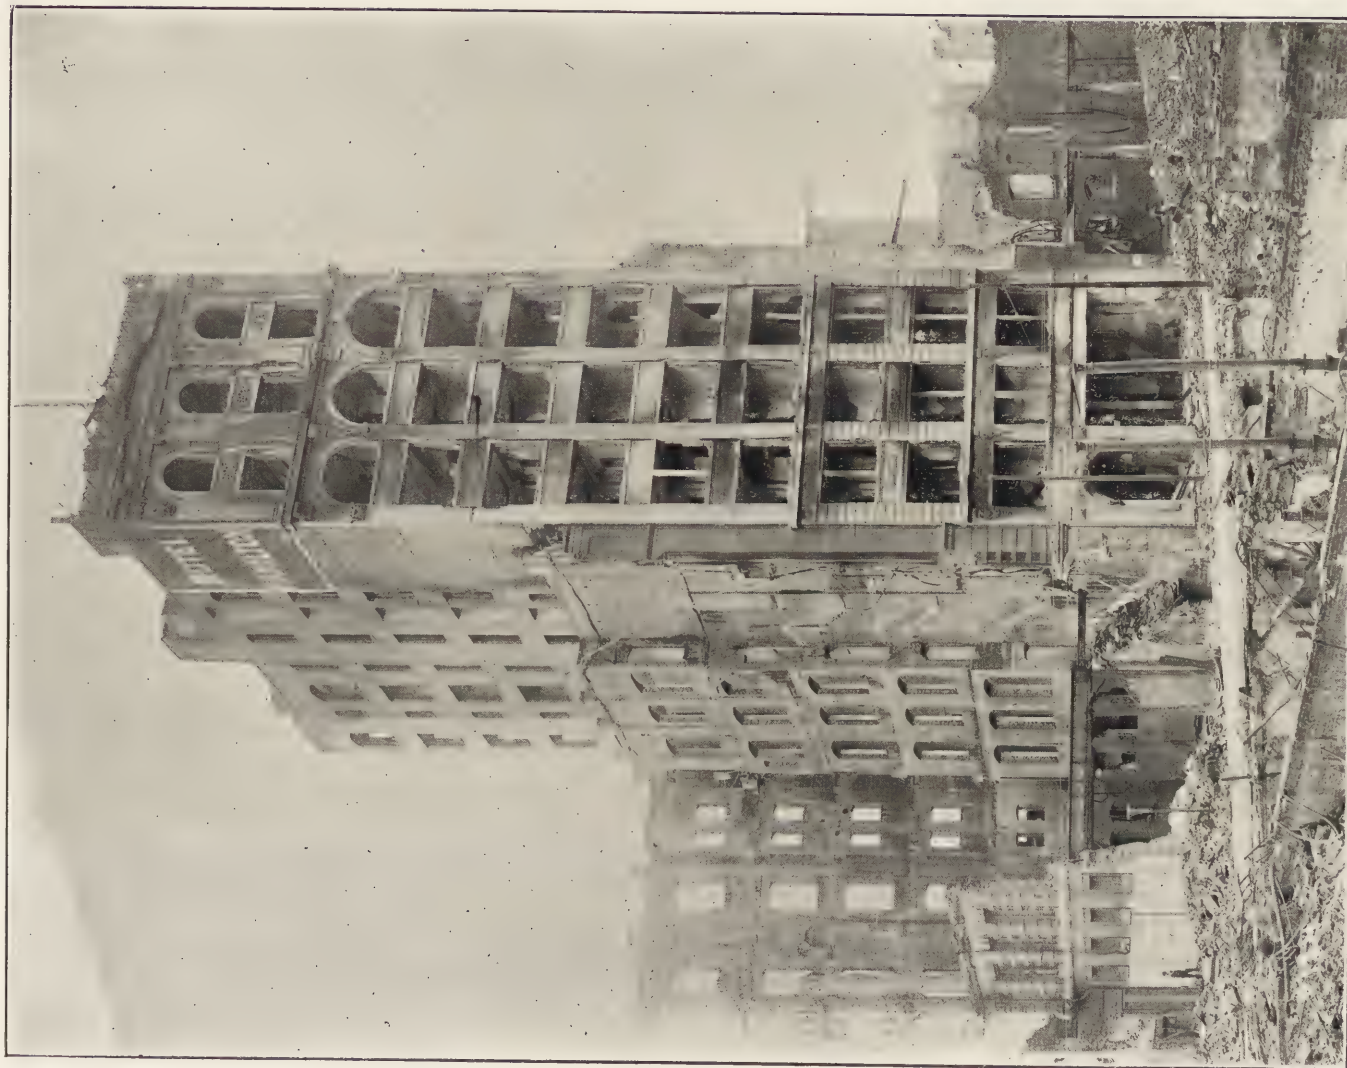
Although the fire in this building was simply normal, and such as would ordinarily be expected to occur in a hotel building, the steel frame is considerably damaged. In the first story, five columns are buckled in the middle portion of the building. In the sixth and seventh stories, a column is buckled west of the elevator shaft. The steel framing around the stairway wells, and the vertical framing of the elevator shaft, are considerably distorted by expansion.

HOTEL HAMILTON. South Side of Ellis Street, between Mason and Powell Streets. The facade, consisting of sand-stone and terra cotta, is considerably damaged, and the metal cornice has fallen away. All of the side and rear walls are more or less damaged by earthquake cracks. In the first story five columns are buckled in the middle portion of the building. Two other columns are buckled in the sixth and seventh stories, west of the elevator shaft. The column failures were caused by flimsy and insufficient furring for the wire lath and plaster. The Collins concrete floors are in good condition. The double lath and plaster partitions, with the Collins slotted stud, are in bad condition, on account of the light gauge stud and the wood stringers to which they are fastened top and bottom.

The failure of the columns was undoubtedly due to the column protection, which was of very flimsy construction. The furring around the columns to support the lath and plaster was very light and inadequate for the requirements.

The repairs required for the exterior of this building will be comparatively slight. The buckling of the columns referred to has caused the floors throughout the entire building to settle. It may be possible to correct this settling and replace the damaged columns without reconstructing the building, but it will be a difficult and expensive operation.

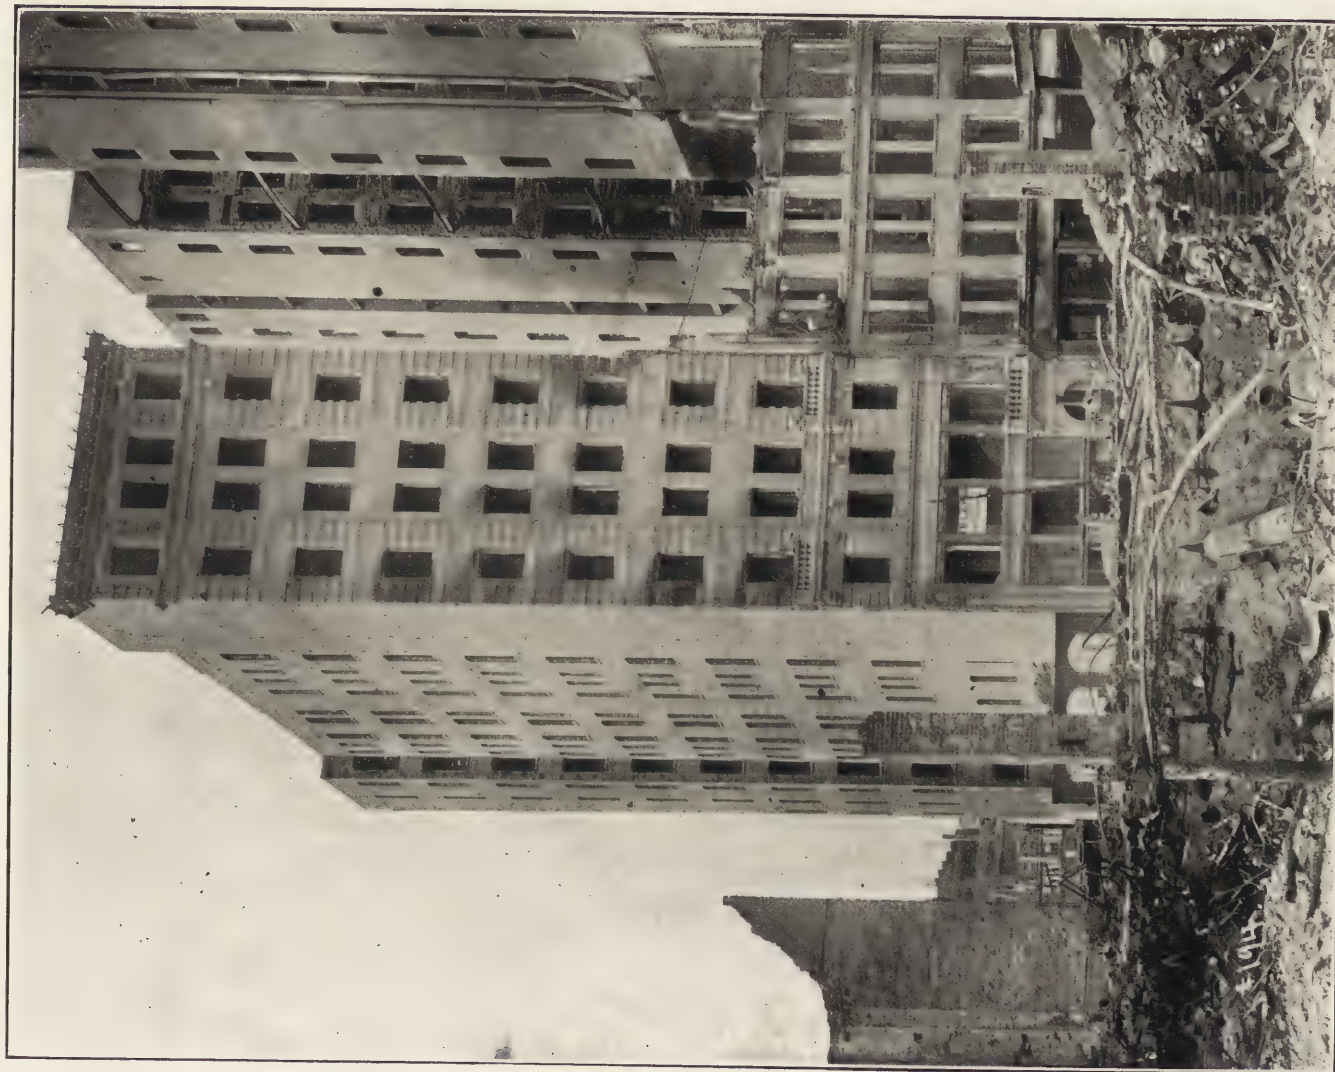
HOTEL ALEXANDER. Geary Street, between Powell and Mason Streets. The facade of sandstone is only slightly damaged by spalling around window openings. The metal cornice has fallen away. Although subjected to only a normal fire, columns have buckled in the third, fifth, sixth, seventh, eighth, ninth and tenth stories, on account of flimsy methods employed in the wire lath and plaster column protection. Notwithstanding the warped condition of the steel work, the Collins concrete floors remain in place and have been very little damaged by the fire. The 2" wire lath and plaster partitions, with the No. 16 gauge Collins slotted metal studs, are badly deflected and bulged throughout. The illustration shows also a portion of the light court of the Hotel St. Francis which was stripped of the face brick during the fire.

Although this building was subjected to a moderate fire only, the large number of column failures are no doubt due to the flimsy furring that was used to support the wire lath and plaster protection around them. In several cases where the wire lath and plaster had been broken down by the buckling of the columns it was noted that there were only two $\frac{1}{4}$ " rod supports for the wire, in a story height, and these supports did not anchor the lath and plaster to the column. They were simply brackets fastened to the partition on both sides of the column, and the wire lath was formed around them.

Except for the buckling of the columns, this building would have been practically uninjured structurally. The replacing of the columns will be an expensive operation, and may involve the reconstruction of a considerable portion of the building. The damage to the exterior is comparatively small.

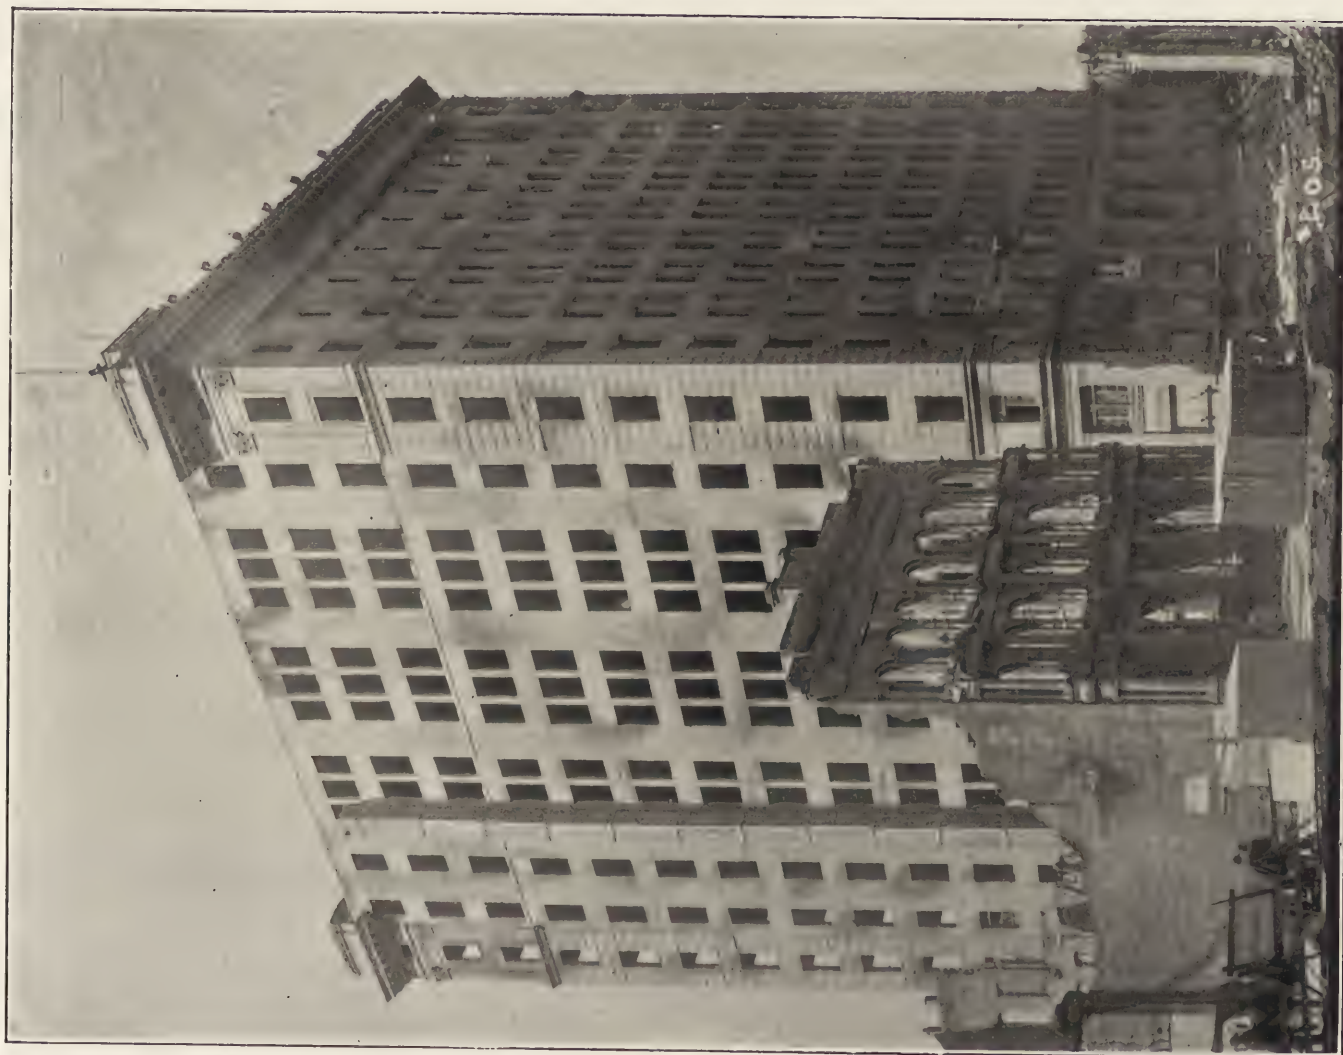
MERCHANTS' EXCHANGE BUILDING. South Side of California Street between Montgomery and Sansome Streets. The facades of gray granite for the first and second stories and buff terra cotta brick with terra cotta ornamentation above, are in good condition, with the exception of the granite, which is badly spalled at the second-story level. The rear walls of common brick are slightly cracked by the earthquake. A falling wall, from a building in the rear, wrecked the skylight and roof over one corner of the exchange room. The steel skeleton frame and the Roehling concrete floors and wire lath and plastered ceilings are uninjured. The double wire lath and plaster column protection is intact. The Roehling wire lath and plaster partitions all remain standing, but are deflected out of plumb in some places. Numerous small vaults and so-called fire-proof safes failed to preserve their contents. This building passed through the earthquake and the fire with as little structural damage as any building in the burned district.

This building withstood the effects of the fire and the earthquake admirably and can be repaired without difficulty.

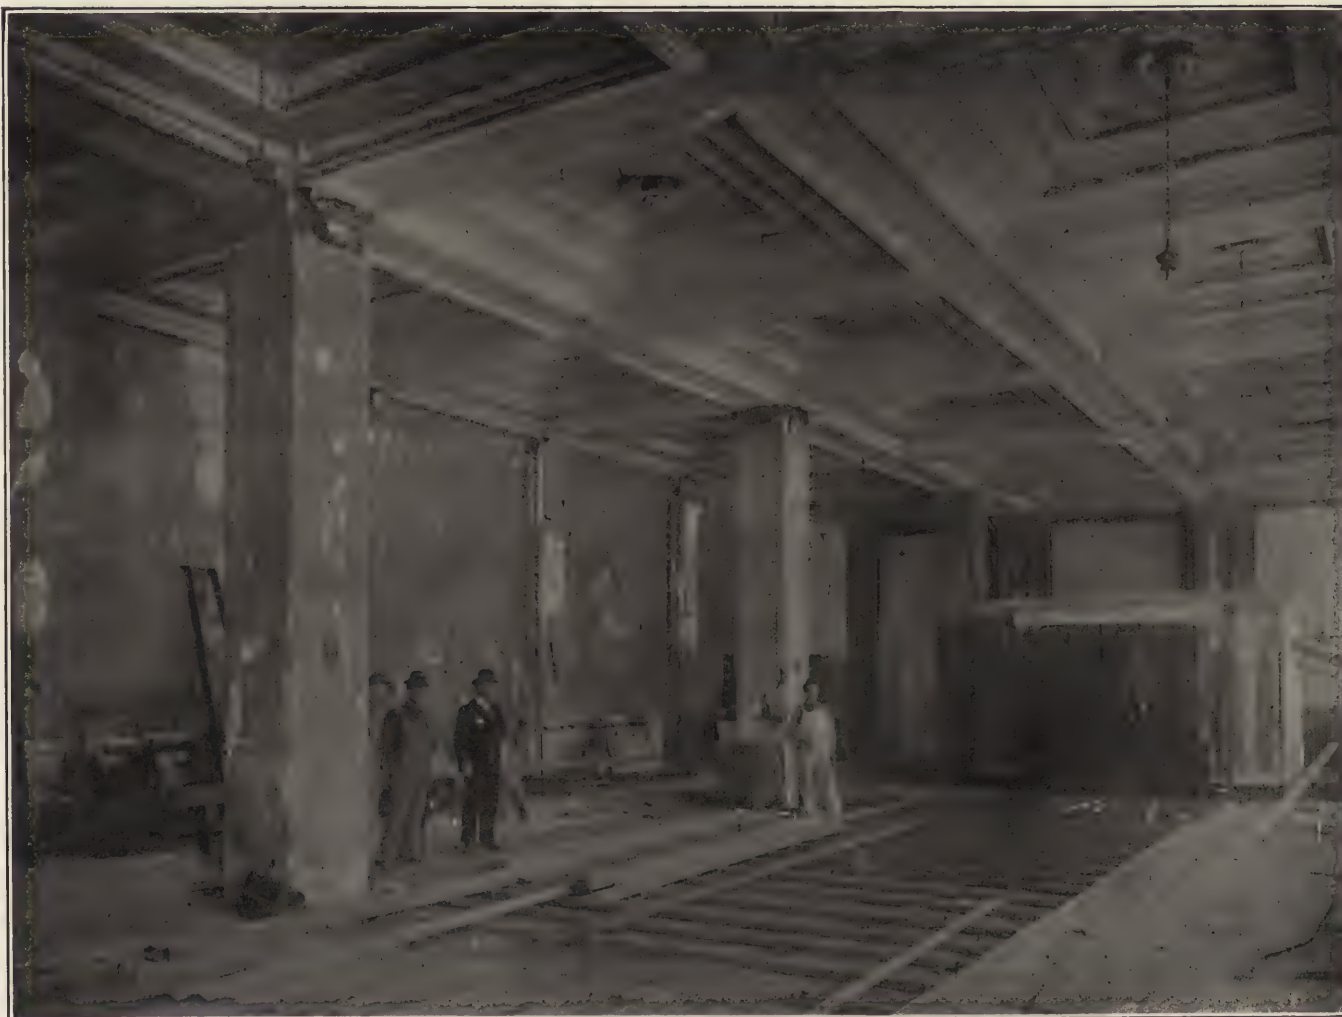
MERCHANTS' EXCHANGE BUILDING. First Story. Showing condition of Roebling fire-proof floors, partitions, column covering and ornamental lath and plaster ceiling in the banking room of the American National Bank. Everything combustible in this room was consumed, the vaults remaining in good condition. A temporary wood floor was being laid at the time that the photograph was taken.

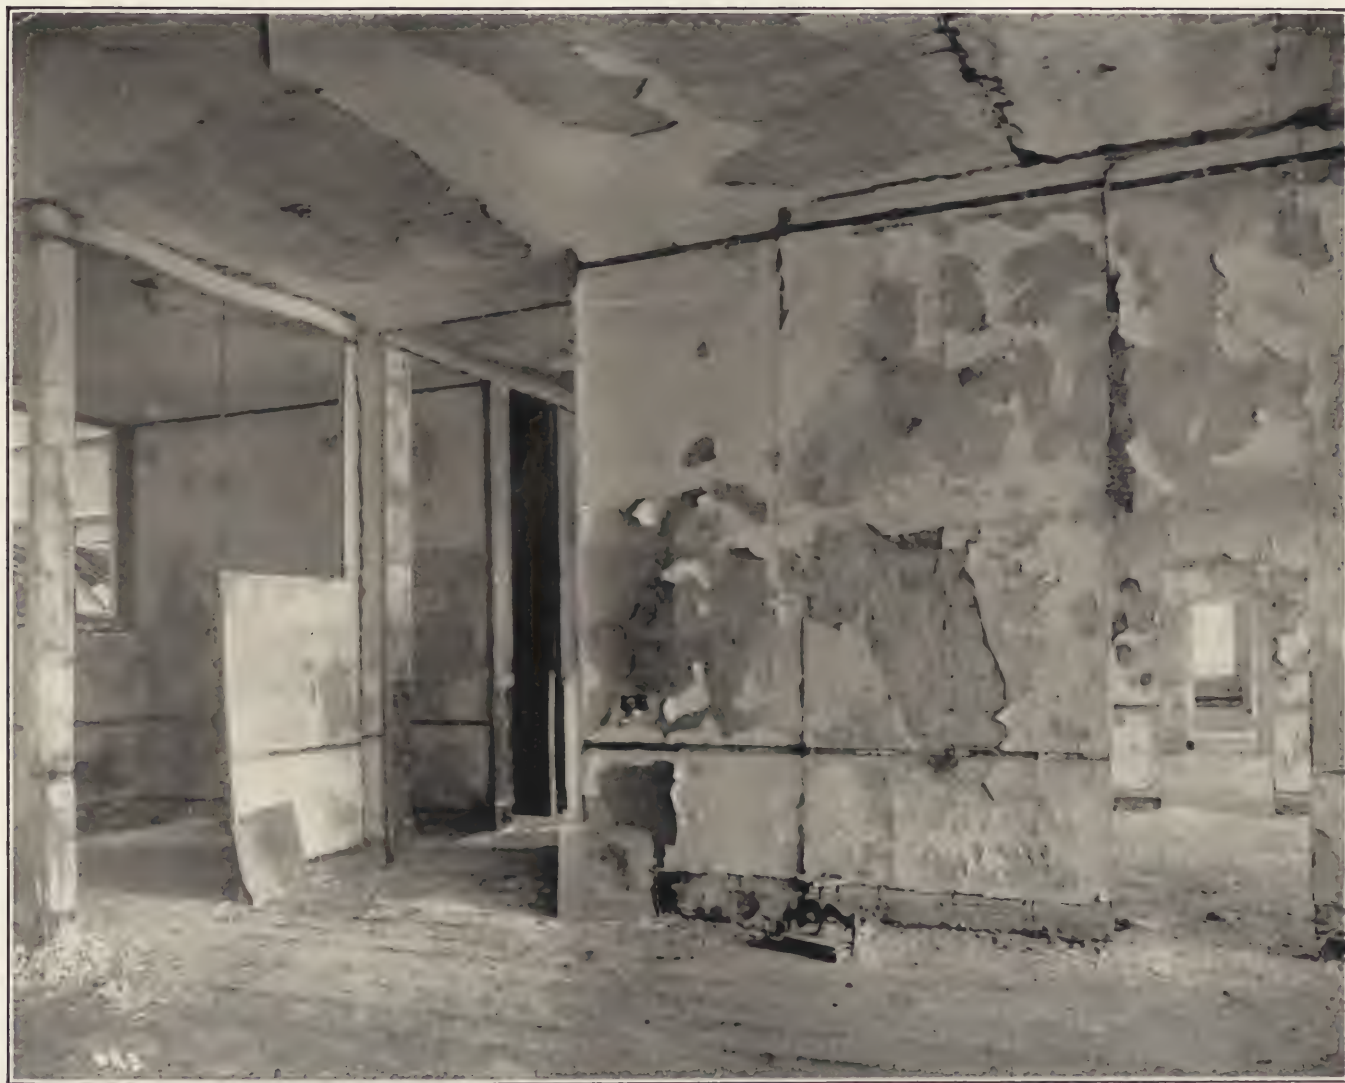
MERCHANTS' EXCHANGE BUILDING. Third Story. Showing typical condition of the Roebling concrete floors and wire lath and plaster ceilings and partitions. This view was taken immediately after the fire. A small amount of plaster on the floors represents practically all the *débris*.
